TRB #01-19

### **Technical Resources Bulletin**

### Subject: Hanger Straps Embedded in Concrete Test Results

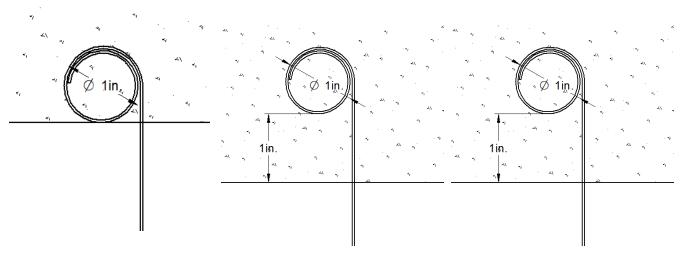
The SMACNA Testing and Research Institute (STRI) completed load tests on three different combinations of strap embedded in concrete. The test specimens included (A) 16 ga x 1 inch wide double coil hanger strap embedded flush with the bottom of the concrete surface; average concrete compressive strength was 3,650 psi; (B) 16 ga x 1 inch wide double coil hanger strap embedded 1 inch from the bottom of the concrete surface; average concrete compressive strength was 3,600 psi; and (C) 16 ga x 1 ½ inch wide double coil hanger strap embedded 1 inch from the bottom of the concrete surface; average concrete compressive strength was 3,850 psi. Figure 1 shows the test configurations for the three types of test specimens. Each scenario was tested five times.

Figure 1 (A) Test Sample 16 ga, x 1 in. wide

Figure 1 (B) Test Sample 16 ga x 1 in. wide

Figure 1 (C) Test Sample 16 ga x 1  $\frac{1}{2}$  in. wide

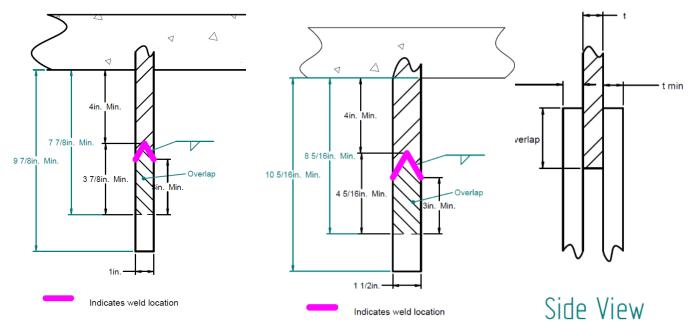
Figure 2 shows how the test samples were constructed. The straps extended below the concrete surface by 4 inches where two pull straps were welded on either side of the sample. Figure 3 shows more details of the pull straps.

Figure 2 - 1 inch and 1 ½ inch Straps Welded to Pull Straps to Apply Load

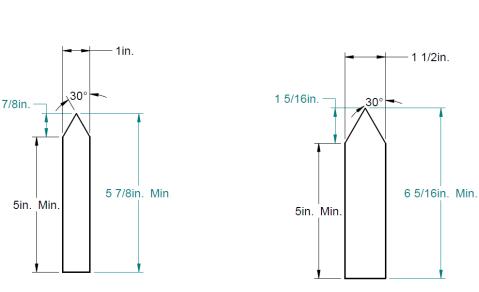
**Pull Straps**

Figure 3 - Pull Straps Details Used to Apply Loads

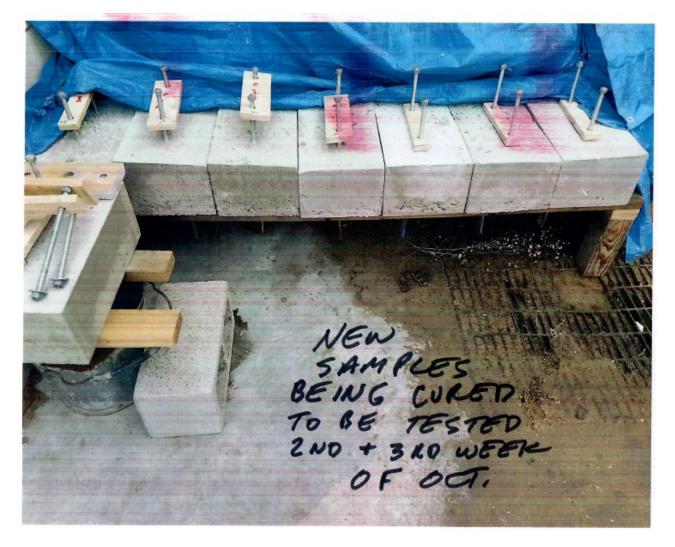
The samples were fabricated including the pull straps and coiled ends. The straps were then placed in a form where concrete was added. Samples were allowed to cure until meeting the 3,600 psi strength requirement before loads were applied. Figure 4 shows test samples being cured. Loads were applied until failure occurred.

Figure 4 New Samples Being Cured

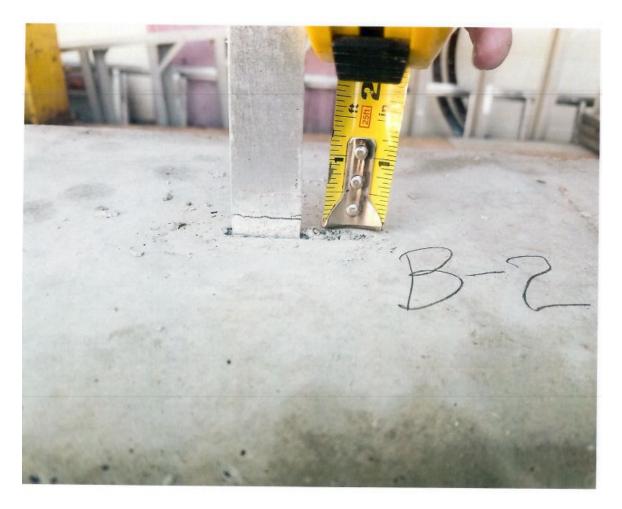
Specimen	Load at Failure (lbs.)	Failure Mode
B-1	2,650	Steel Strap Specimen Pulled Out of Concrete (See Figure 7)
B-2	2,410	Steel Strap Specimen Pulled Out of Concrete (See Figure 7)
B-3	2,290	Steel Strap Specimen Pulled Out of Concrete (See Figure 7)
B-4	2,790	Steel Strap Specimen Pulled Out of Concrete (See Figure 7)
B-5	2,310	Steel Strap Specimen Pulled Out of Concrete (See Figure 7)
Average	2,490	
Standard Deviation	220

Note: The concrete was initially cracked parallel to the plane of the strap

Figure 7 Sample Specimen B-2, Failure Mode for 16 Gage 1 Inch Wide Double Coil Straps, Hanger Embedded 1 Inch From the Concrete Surface

- None of the hanger straps failed.
- The mode of failure was the concrete gave way in a cone shape for (A) specimens
- The mode of failure was the hanger strap pulled out of the concrete for (B) specimens
- The mode of failure was the hanger strap pulled out of the concrete for (C) specimens

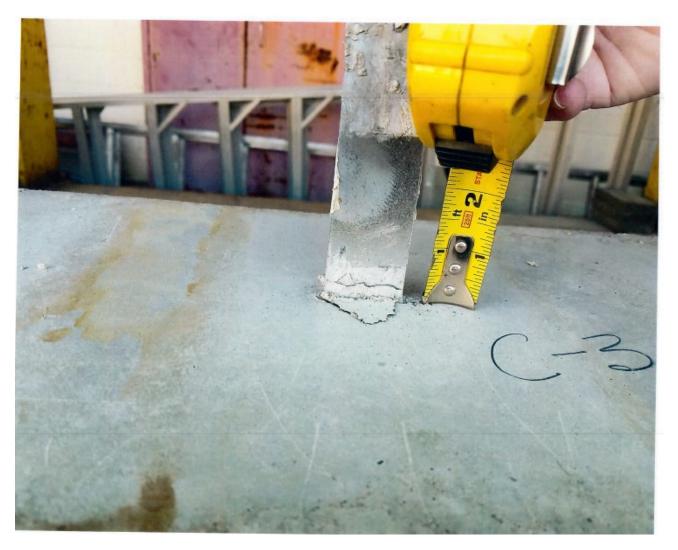
Specimen	Load at Failure (lbs.)	Failure Mode
C-1	4,020	Steel Strap Specimen Pulled Out of Concrete (See Figure 8)
C-2	3,780	Steel Strap Specimen Pulled Out of Concrete (See Figure 8)
C-3	4,350	Steel Strap Specimen Pulled Out of Concrete (See Figure 8)
C-4	3,910	Steel Strap Specimen Pulled Out of Concrete (See Figure 8)
C-5	4,090	Steel Strap Specimen Pulled Out of Concrete (See Figure 8)
Average	4,030	
Standard Deviation	214

Note: The concrete was initially cracked parallel to plane of strap

Figure 8 Sample Specimen C-3, Failure Mode for 16 Gage 1 ½ Inch Double Wide Coil Straps, Hanger Embedded 1 Inch From the Concrete Surface

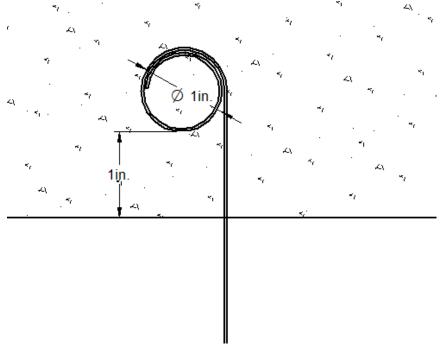
Figure 4

Unless otherwise approved, the allowable load on an upper attachment is ¼ of the failure load. For properly installed coils (embedded at least one inch), increasing the strength of the concrete would make no anticipated change in capacity assuming a minimum of 3,600 psi compressive strength because the concrete did not fail. The concrete strength would make a difference in a flush mounted coil, at least until the mode of failure becomes strap slippage, but that is not a recommended approach. The hanger strap thickness would only make a difference if the strap capacity is less than the "coil capacity". This is because the straps themselves did not fail either. Since the mode of failure was slippage which is related to "friction" and as the testing indicated wider straps which have more surface area had a higher capacity. Since the upper attachment, the coil in this case, is only part of the hanger system you must consider the capacity of the strap itself before determining the total capacities for the coils and Figure 9 shows the strap capacities found in Table 5-1 of SMACNA's HVAC Duct construction Standards Metal and Flexible 3<sup>rd</sup> edition. You must use the lower of the two capacities based on your construction options.
